TEST OF AN ELECTROHYDRAULIC DIGITAL ACTUATOR FOR ADVANCED MISSILE SYSTEMS

TECHNICAL REPORT AFWAL-TR-80-2001

Final Report for Period September 1978 - September 1979

BENDIX RESEARCH LABORATORY
REPORT OF REACTION PIN SPACER
FAILURE

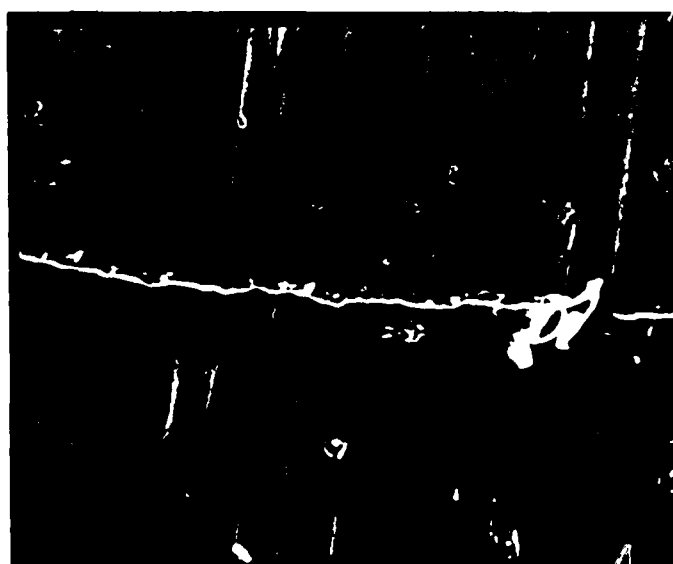
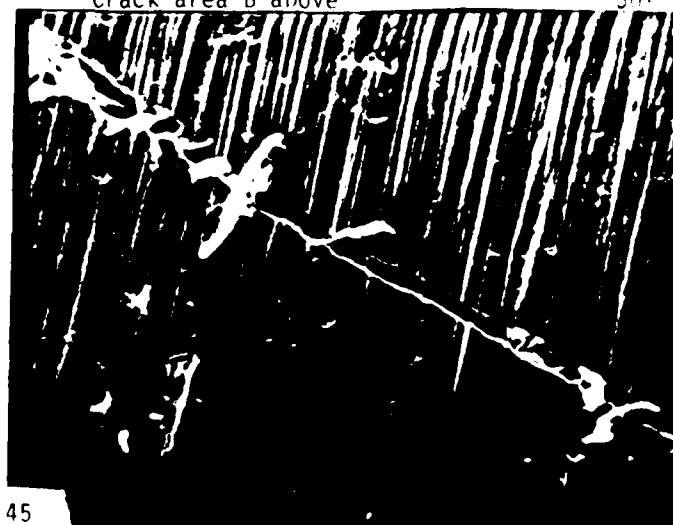
The outer surface of the spacer which failed during the life test contains a large number of deep long cracks, originating on the surface and running parallel to the spacer axis. Evidence of abrasive wear and some adhesive wear damage and poor surface finish (from machining) is observed, along with residue of debris particles and chips (Figures 2 to 6).

Figure 2. Outer surface of pin spacer piece A (of Fig. 1), showing the presence of deep long cracks running parrallel to the spacer length. Evidence of abrasive wear and poor initial surface finsih (machining) is observed, along with the presence of debris and chips.

1. The contacting surfaces (rotor and spacer) must be fabricated to a smooth surface finish, and thoroughly cleaned following the lengthy machining and heat treatment step, so as to minimize the presence of trapped particles and avoid surface damage by wear.
2. Again, final machining should be carried out gently and in no way should result in surface scoring, and damage, since fatigue life of the spacer is very sensitive to its surface condition.
3. During the heat treatment, triple tempering in air might be replaced by a double treatment in an inert atmosphere, and hardness values 60 Rc or higher should be achieved (this also provides the desired alloy high compressive strength).

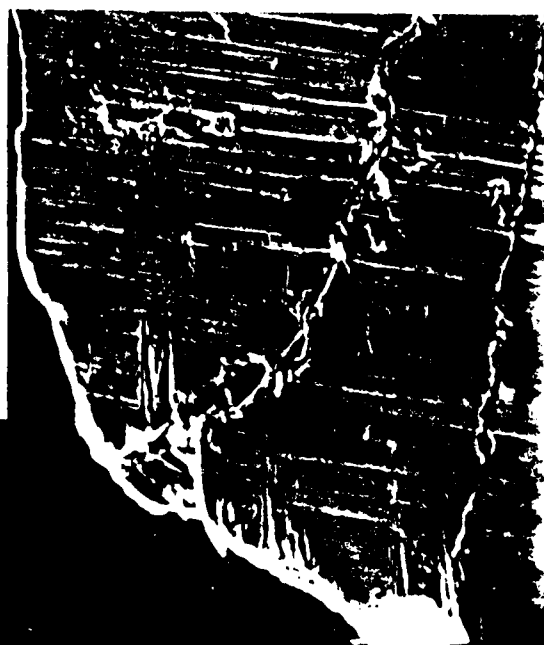
Figure 3. Outer surface of pin spacer piece B, showing abraded surface full of scratches, surface pits, and many cracks originating from the spacer outer surface.

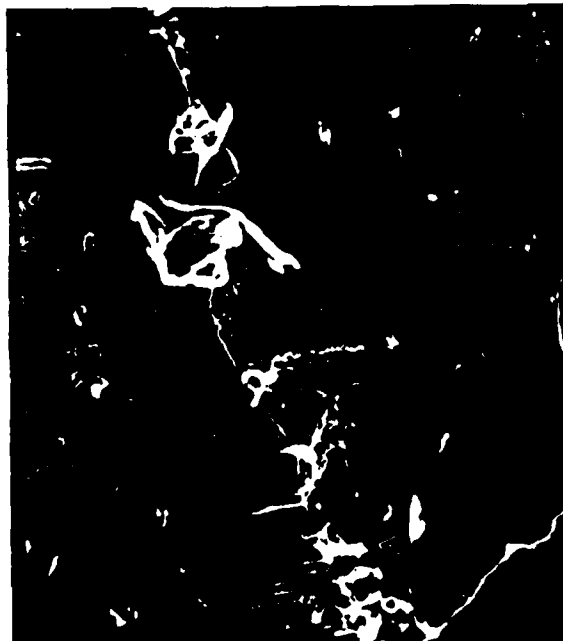
Figure 4. Outer surface of piece C showing the same surface damage observed for pieces A and R, and the presence of particle chips. Notice the deep grooves and scratches (impressions) caused by those particles sliding against the spacer surface.

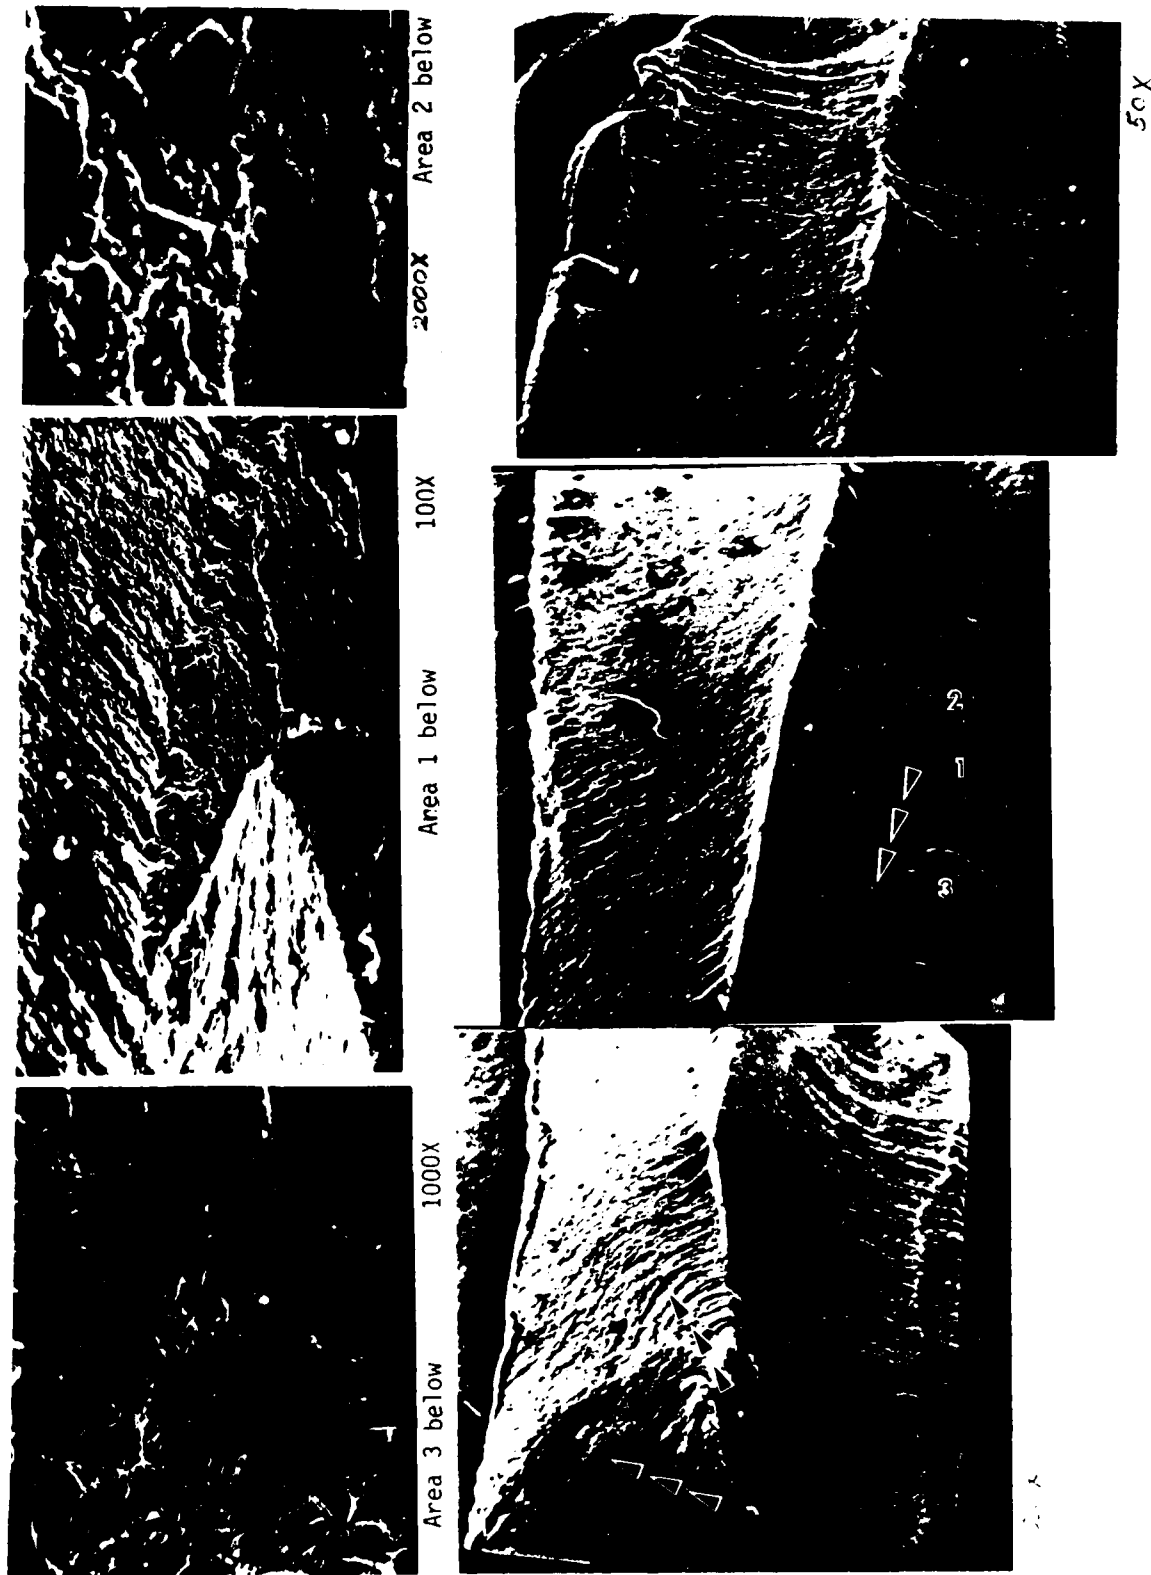
Figure 15. Fracture surface of piece C of the failed spacer showing zones of crack initiation and propagation (arrows).

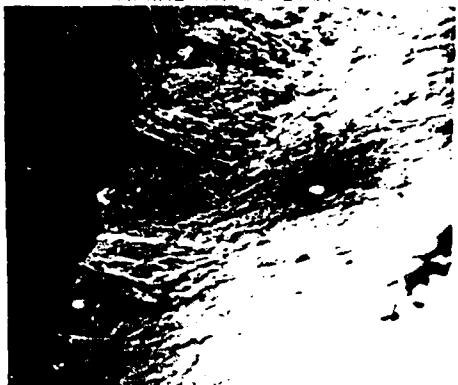
Some crack sites on the inner wall of the spacer as a result of poor machining

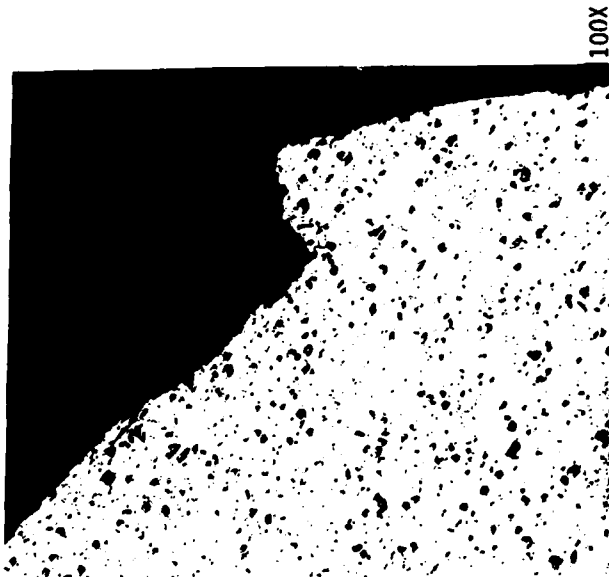
Area near A enlarged showing small cracks
1, 2 propagating from the outer surface of
the spacer.

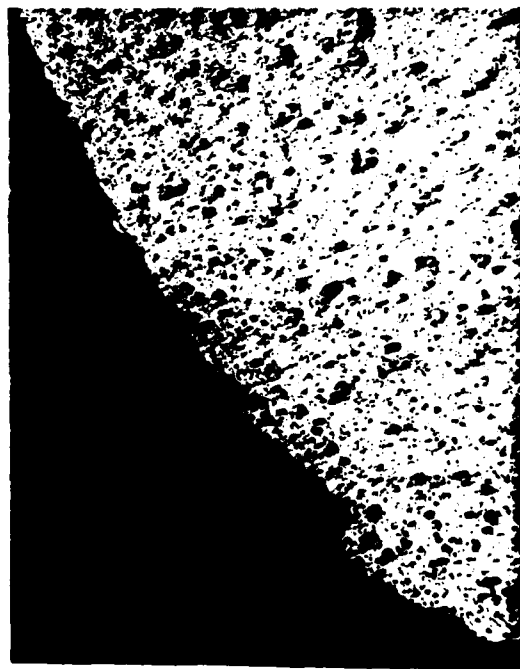
Area near B enlarged, showing
cracks at the outer spacer
surface (at 3, 4)
